DEPARTMENT OF TRANSPORTATION**DIVISION OF ENGINEERING SERVICES**

Quality Assurance and Source Inspection

Contract #: 04-0120F4Cty: SF/ALA Rte: 80 PM: 13.2/13.9File #: 1.28**WELDING INSPECTION REPORT****Resident Engineer:** Casey, William**Address:** 333 Burma Road**City:** Oakland, CA 94607**Report No:** WIR-026879**Date Inspected:** 13-Dec-2011**Project Name:** SAS Superstructure**OSM Arrival Time:** 700**Prime Contractor:** American Bridge/Fluor Enterprises, a JV**OSM Departure Time:** 1730**Contractor:** American Bridge/Fluor Enterprises, a JV**Location:** Job Site

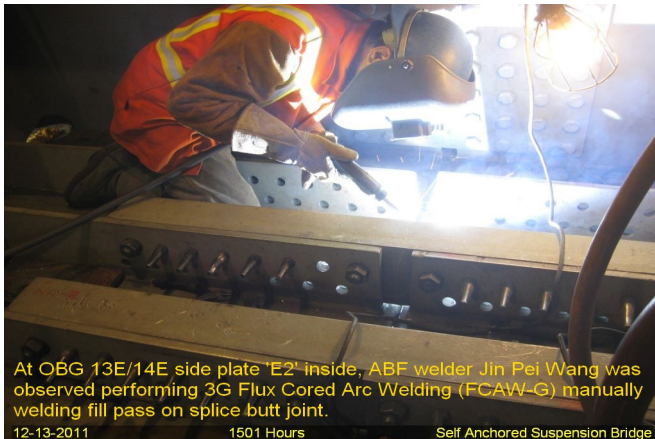
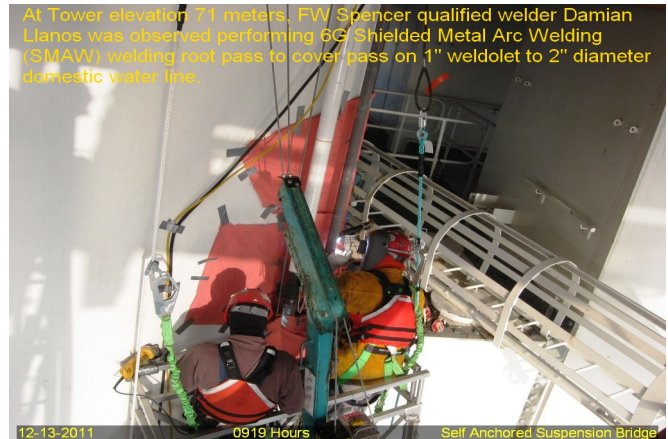
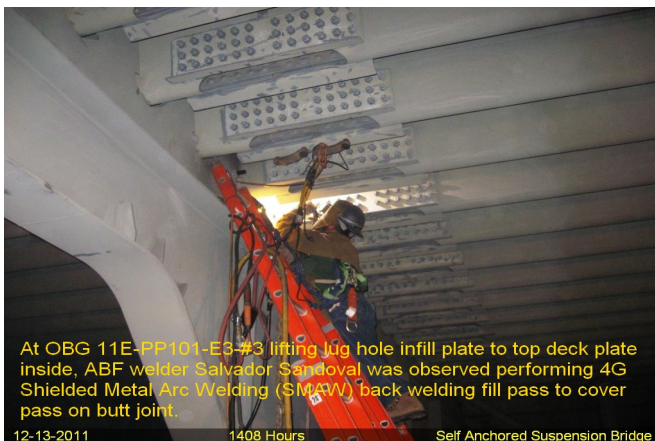
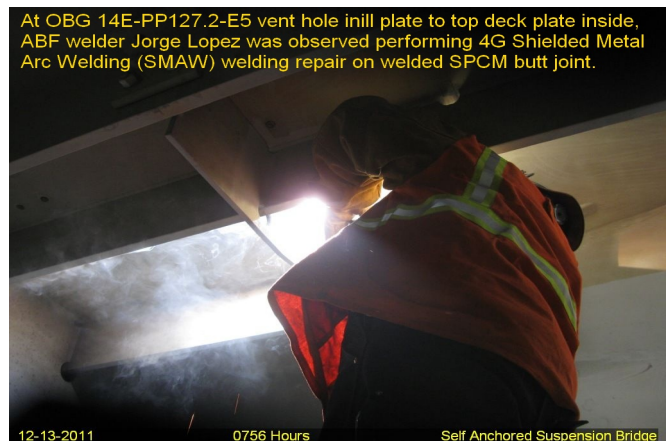
This QA together with FW Spencer foreman have performed visual test (VT) verification on all completed butt joints of the 2" and 3" domestic water and air lines from elevation 56 meters to 79 meters of the tower. The following welded butt joints and branches were VT verified and deemed acceptable to contract requirements;
